TECHNICAL MEMORANDUM FOR RECORD

To	HQMC (LFL) / MCICOM (GF-EV) REVA Program File
CC	NAVFAC Atlantic REVA Program Manager
Subject	Range Environmental Vulnerability Assessment (REVA) Periodic Review Documentation of Findings for Marine Corps Base (MCB) Hawaii
From	(b) (6) Project Manager AECOM Technical Services Inc.
Date	November 19, 2020

Executive Summary

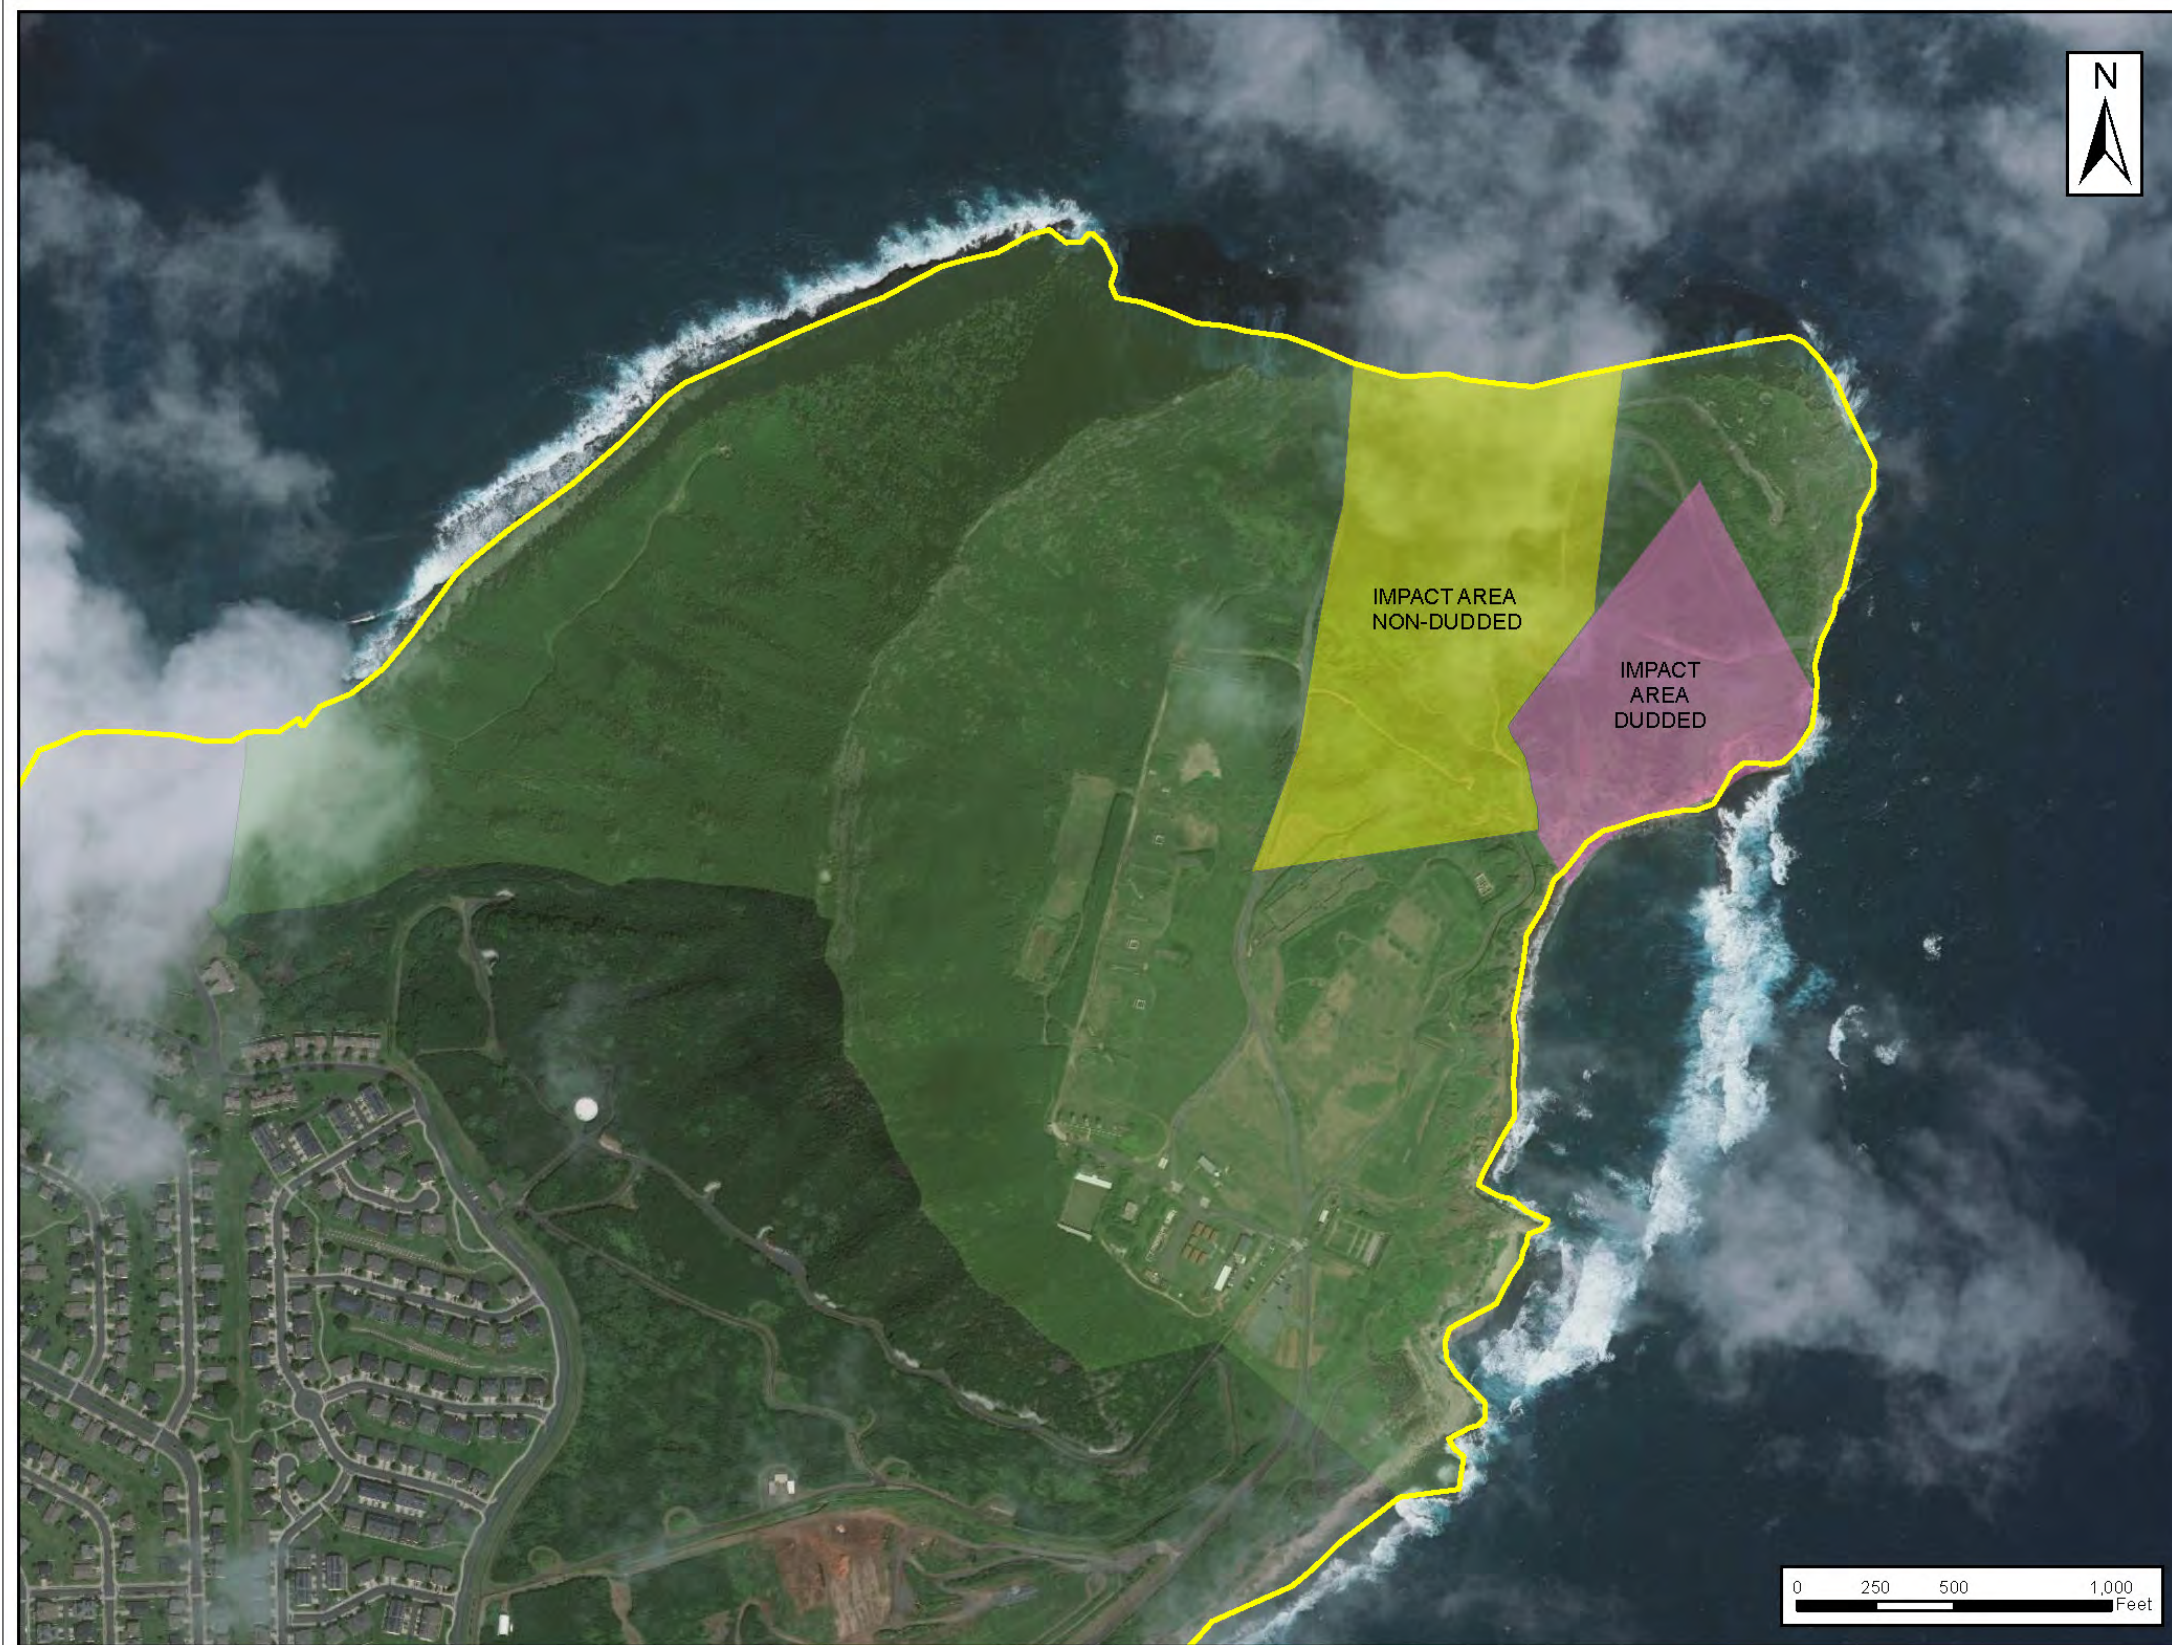
Figure 2a
MCB Hawaii
KBRTF Ranges

- Impact Area - Dudded
- Impact Area - Non-Dudded
- Military Training Location
- Installation Boundary

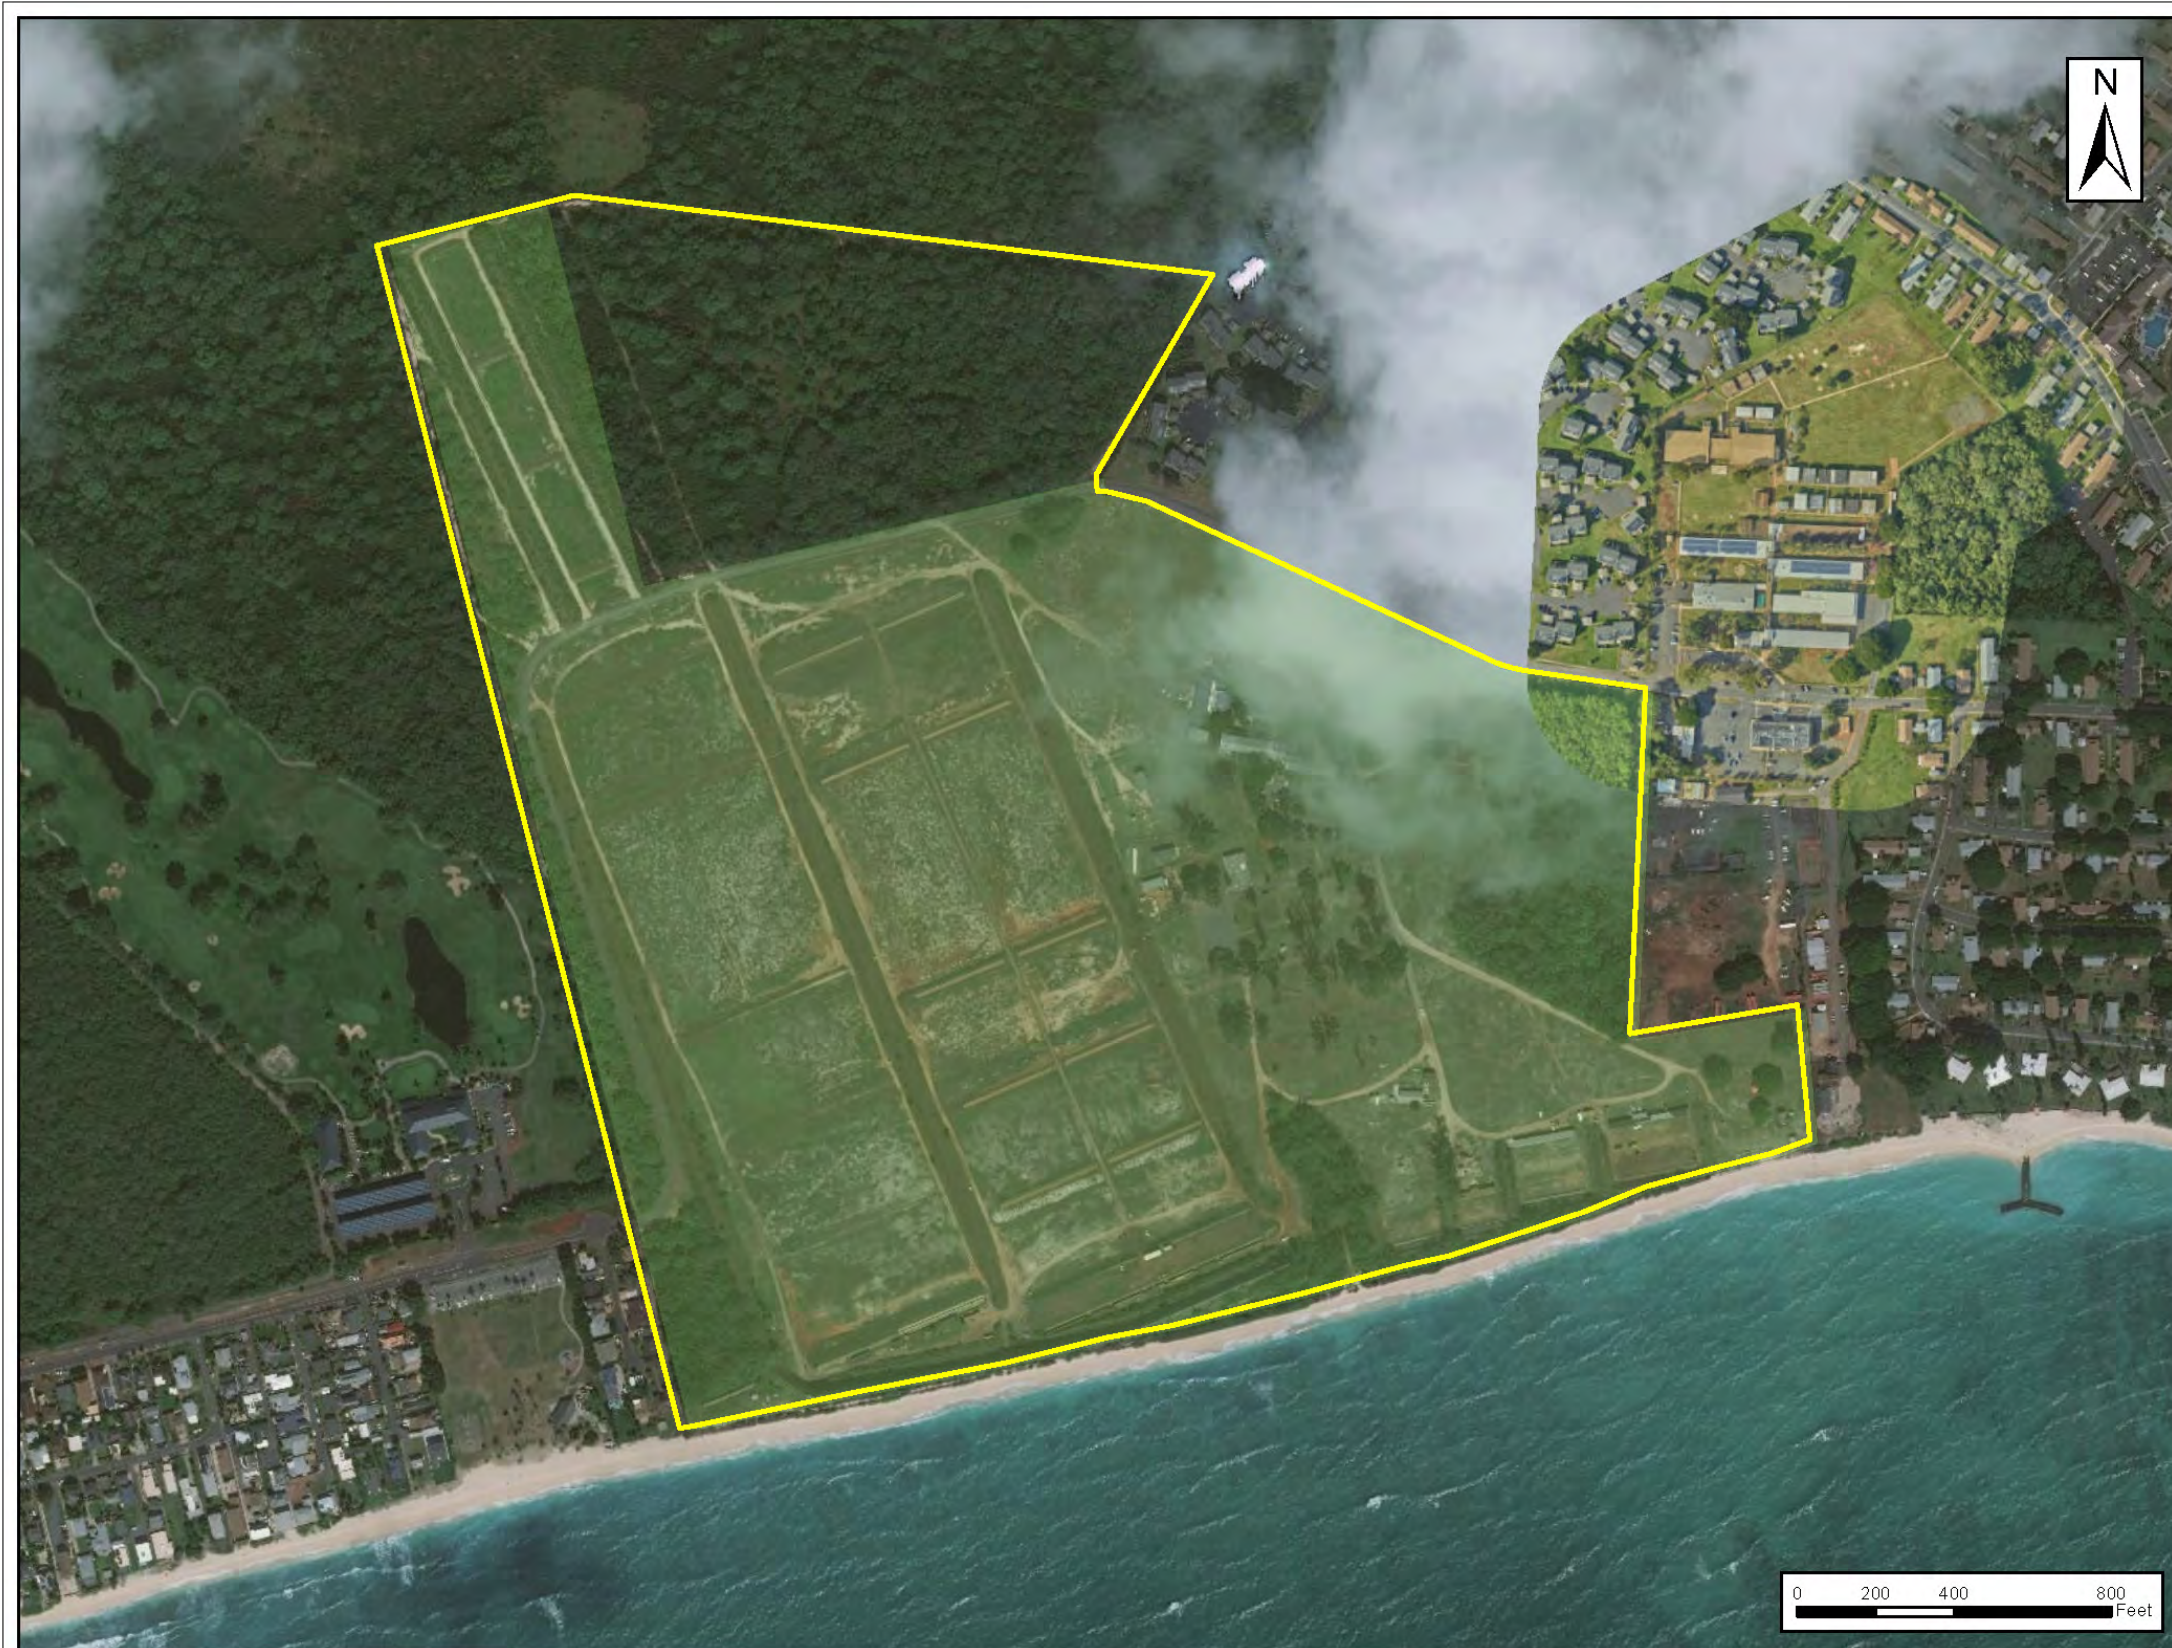
Figure 2b
MCB Hawaii
PRTF Ranges

Note: R-A is referred to as Alpha
Range, R-B is Bravo Range, etc.

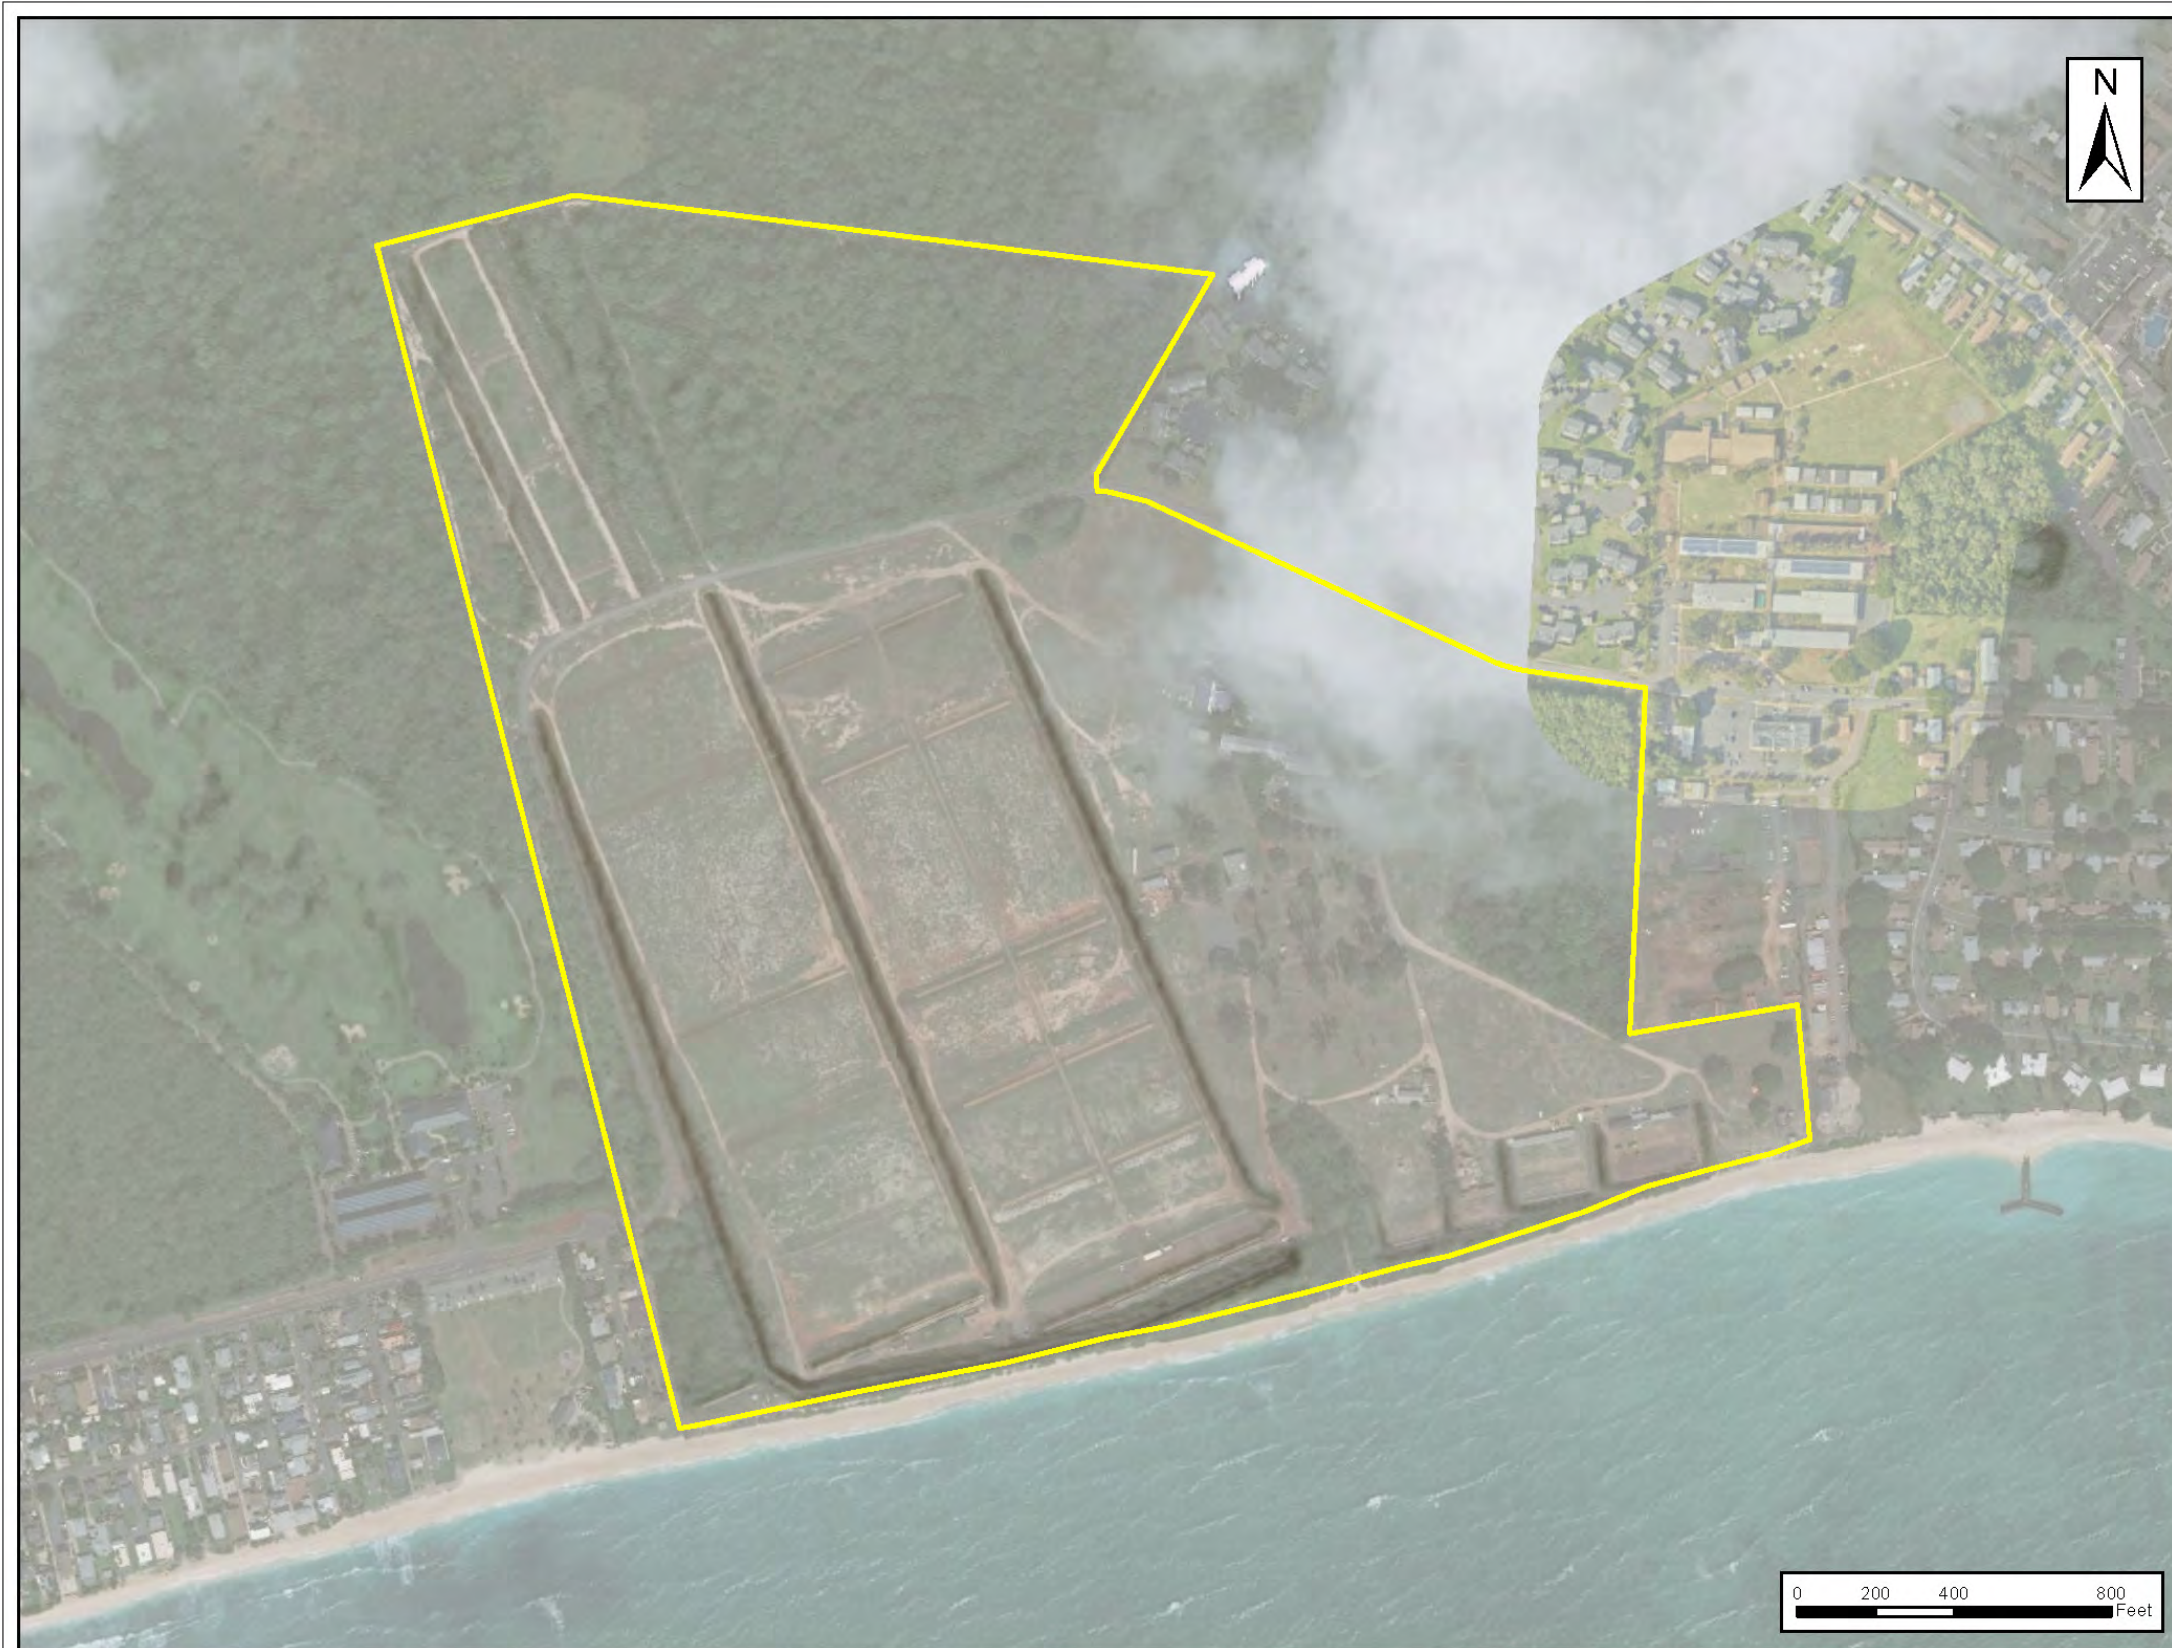
Figure 4b
MCB Hawaii
PRTF Surface Water

Berm

At PRTF, the primary source of MC migrating off range is from impounded stormwater from the front of the berms that infiltrates to the groundwater table and flows into the ocean. Topography is relatively flat with connecting impact and side berms that limit runoff to areas outside the range footprint. Rainfall totals are low to moderate and surface soils have high permeability. These conditions are conducive to MC migration via infiltration to the shallow groundwater table with subsequent discharge into the ocean. Therefore, infiltration to groundwater is a potential migration pathway.
